**HYDRAULIC MODEL  
INVESTIGATION**

AD-A134 641  
**Placer Creek High-Velocity Channel  
and Debris Basin at Wallace, Idaho**

**SPONSORED BY  
U. S. ARMY CORPS OF ENGINEERS  
SEATTLE DISTRICT**

**CONDUCTED BY  
DIVISION HYDRAULIC LABORATORY  
U. S. ARMY CORPS OF ENGINEERS  
NORTH PACIFIC DIVISION  
BONNEVILLE, OREGON**

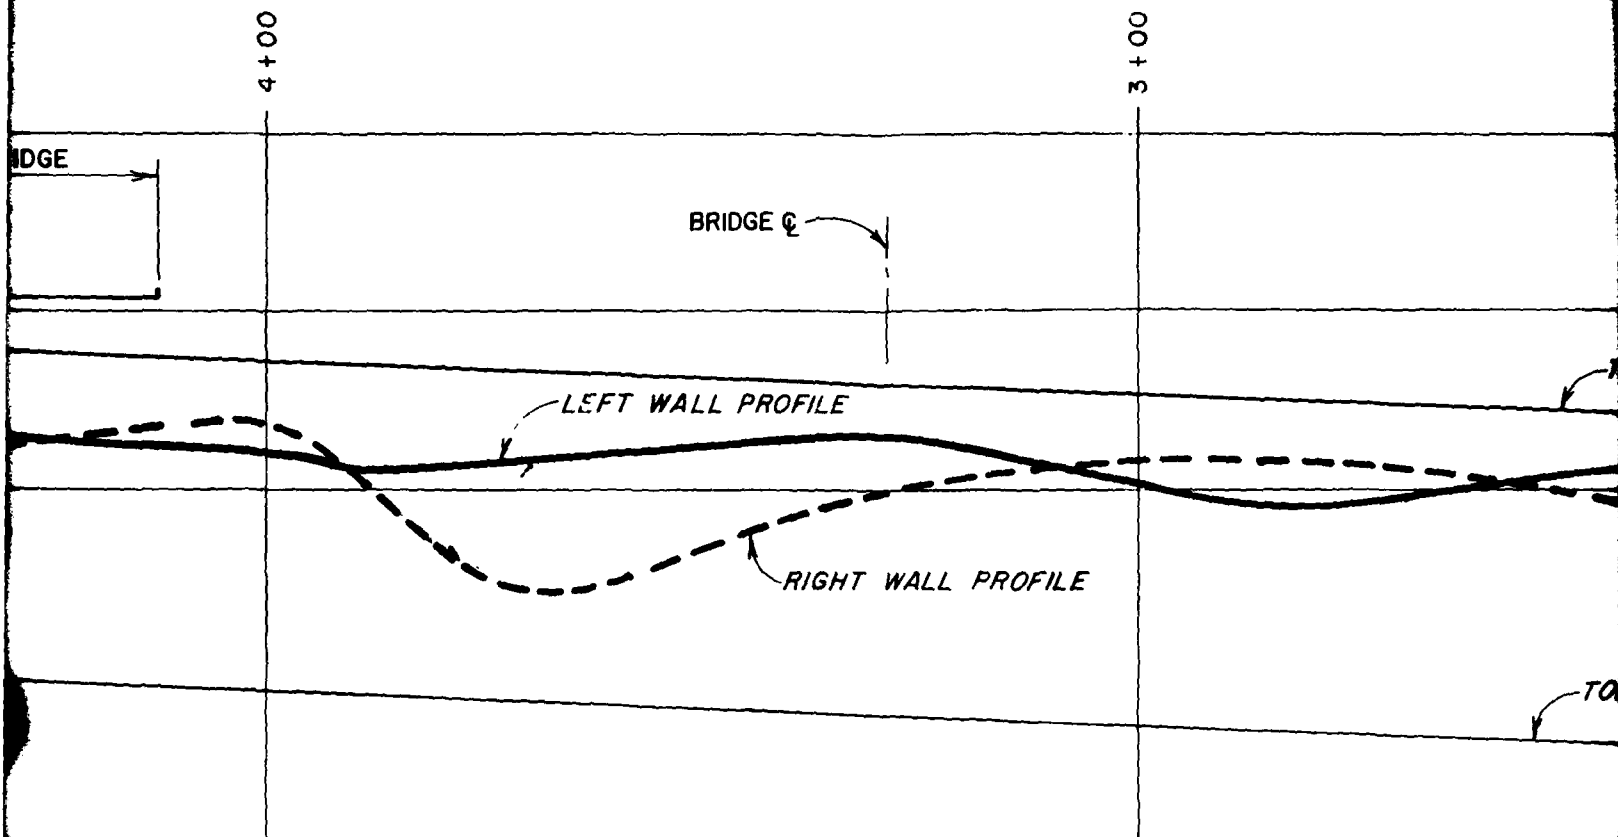
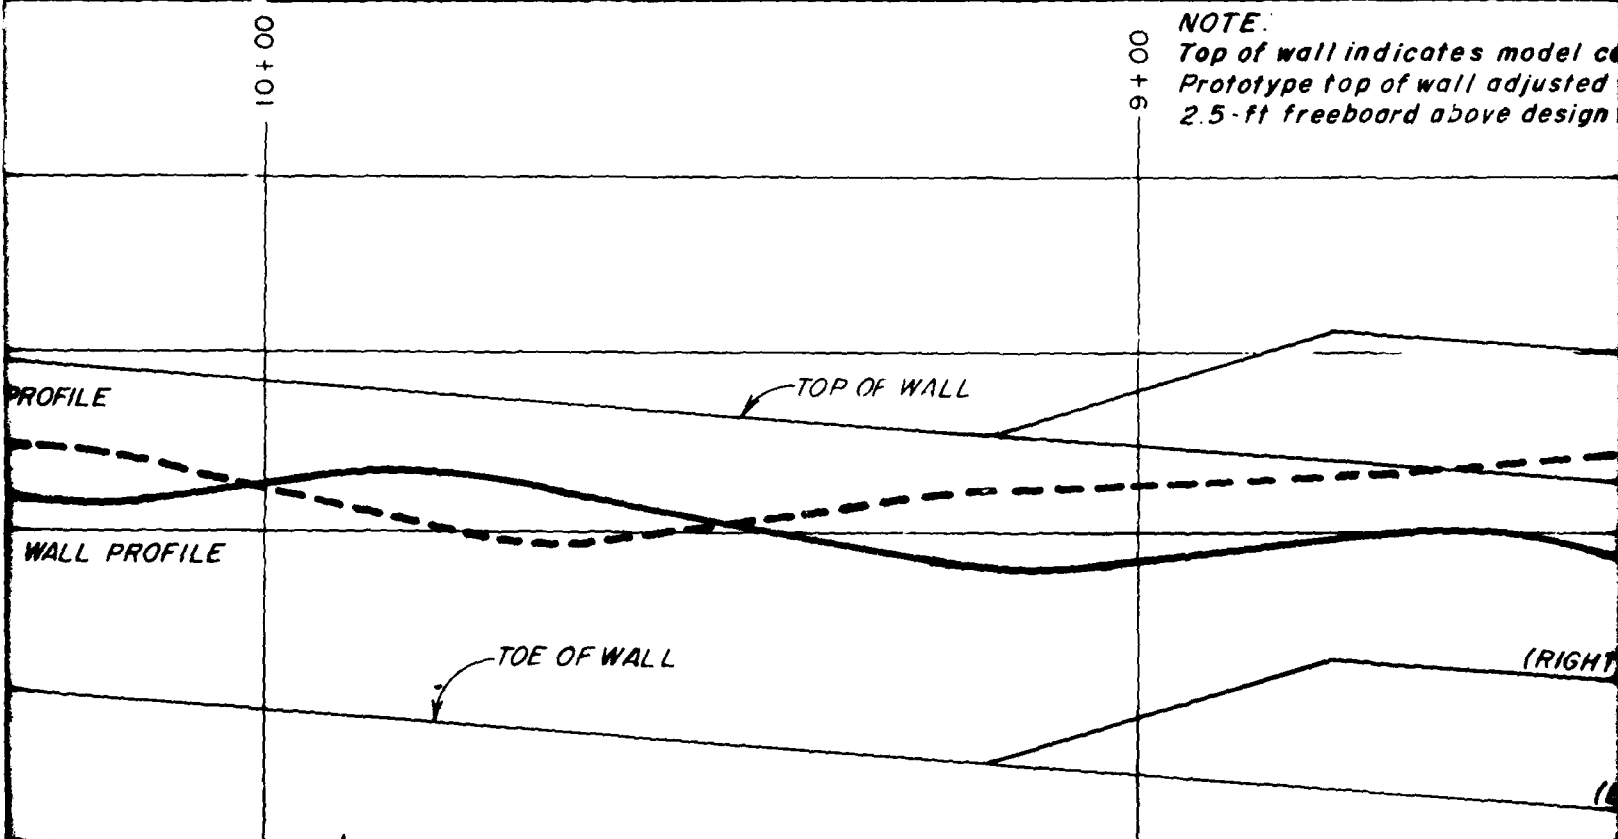
LEFT WALL PROFILE

NOTE:  
Top of wall indicates model of  
Prototype top of wall adjusted  
2.5-ft freeboard above design

41. With one minor modification, the original channel design proved to be hydraulically acceptable. The modification consisted of replacing two short reverse curves with a straight-line transition which corrected the condition. The water surface elevations as determined from the model were used to design the prototype wall heights.

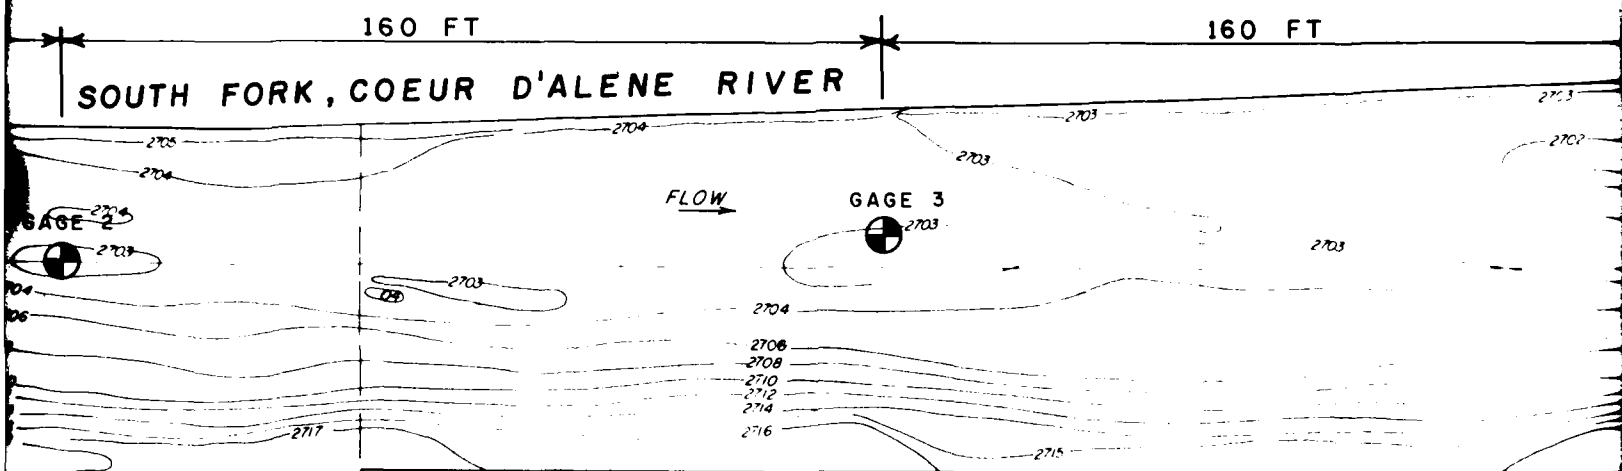
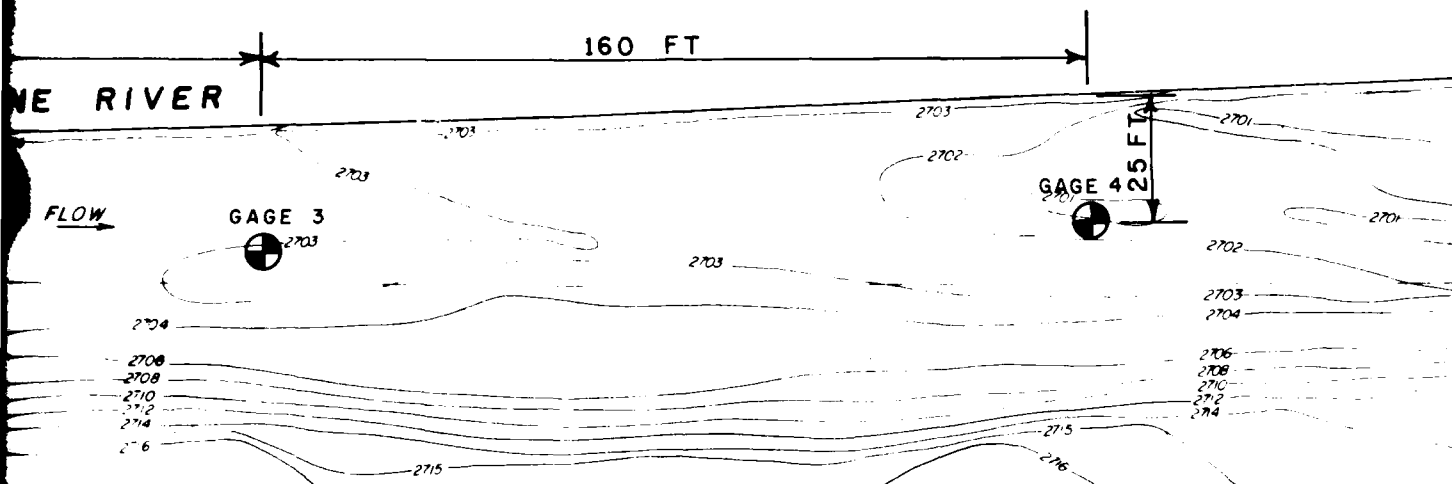
**GAGE LOCATIONS**  
EXISTING RIVERBED  
AT CONFLUENCE

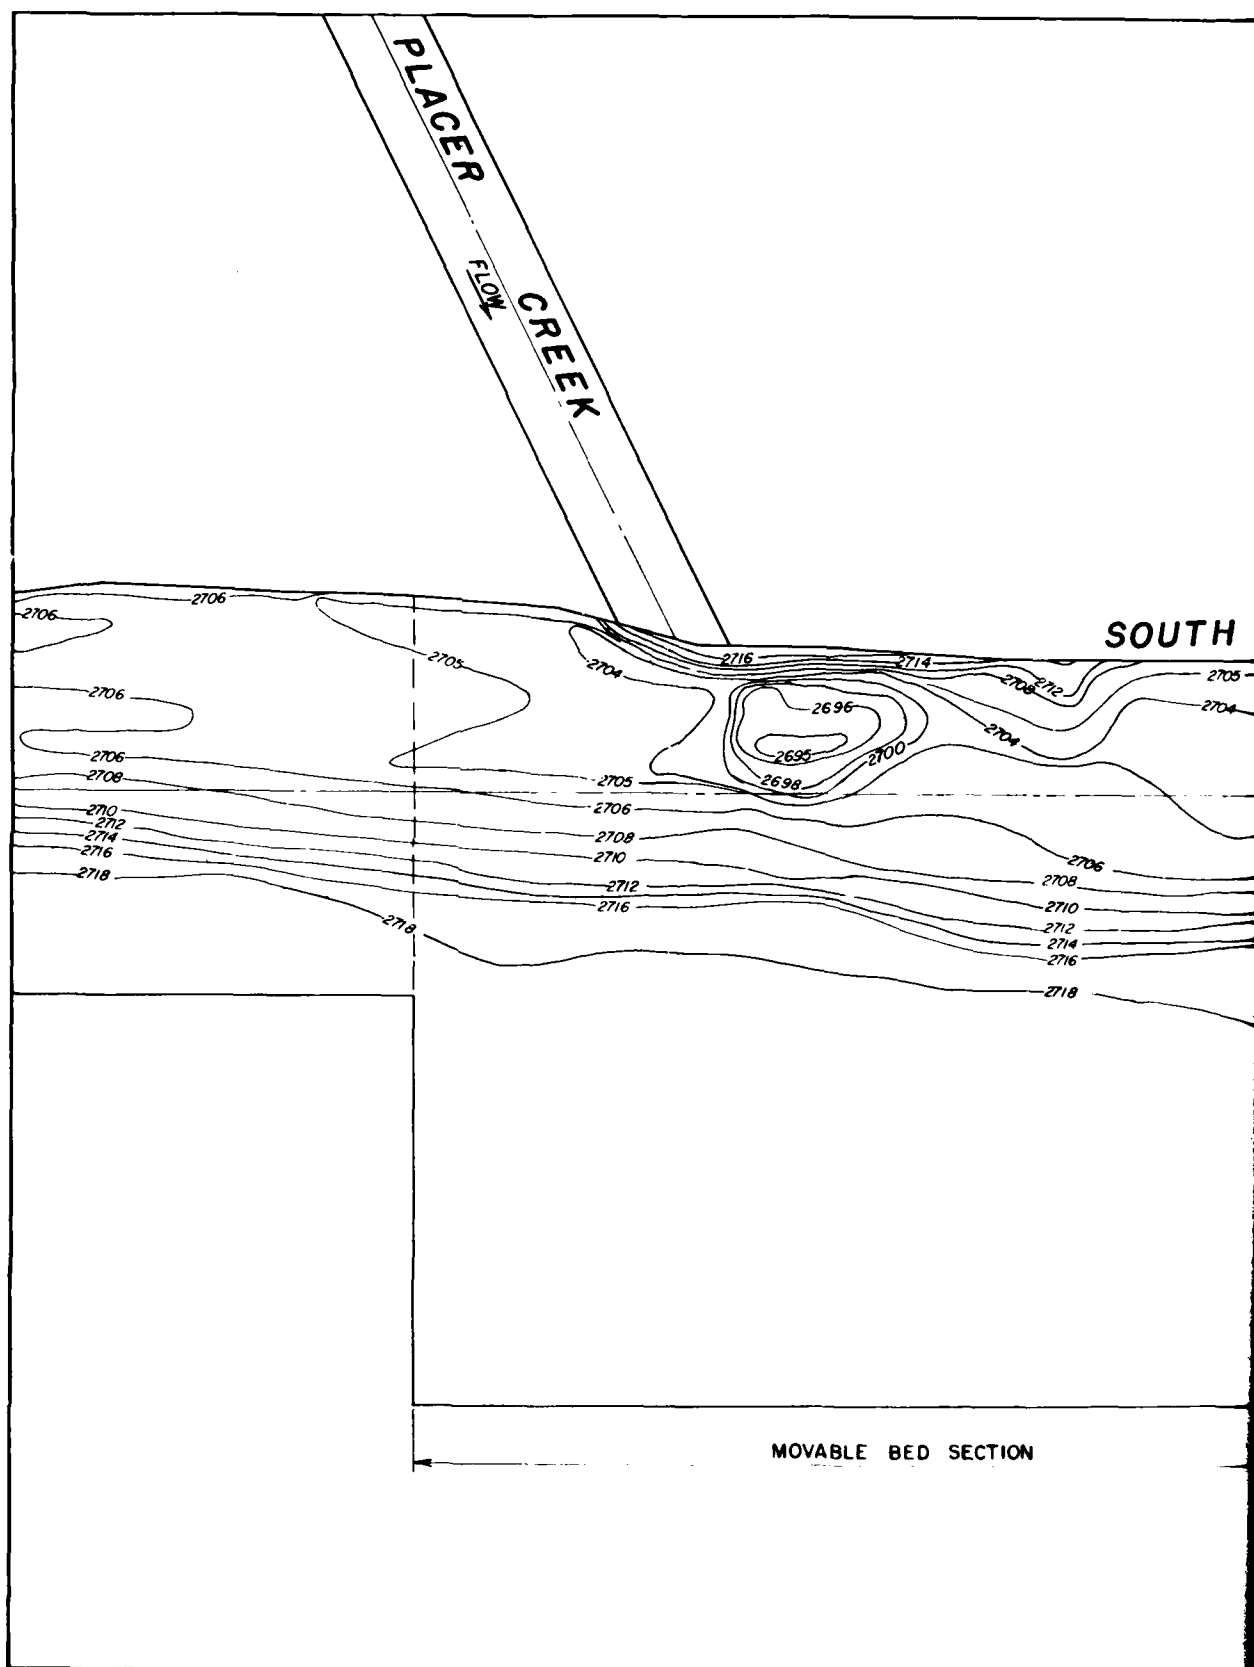
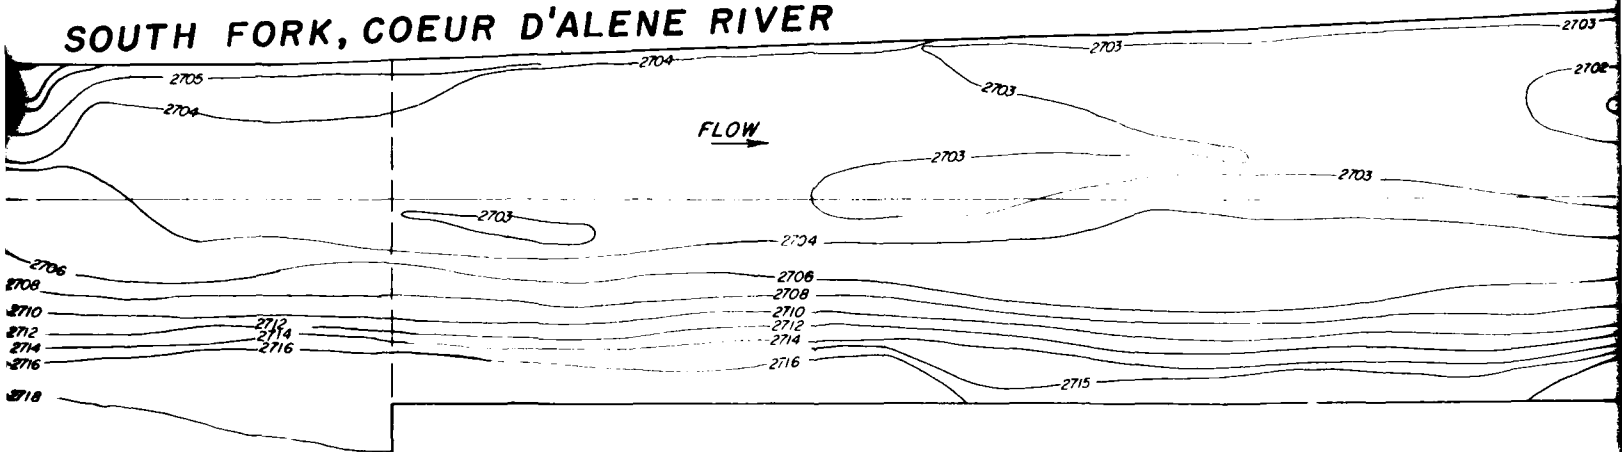
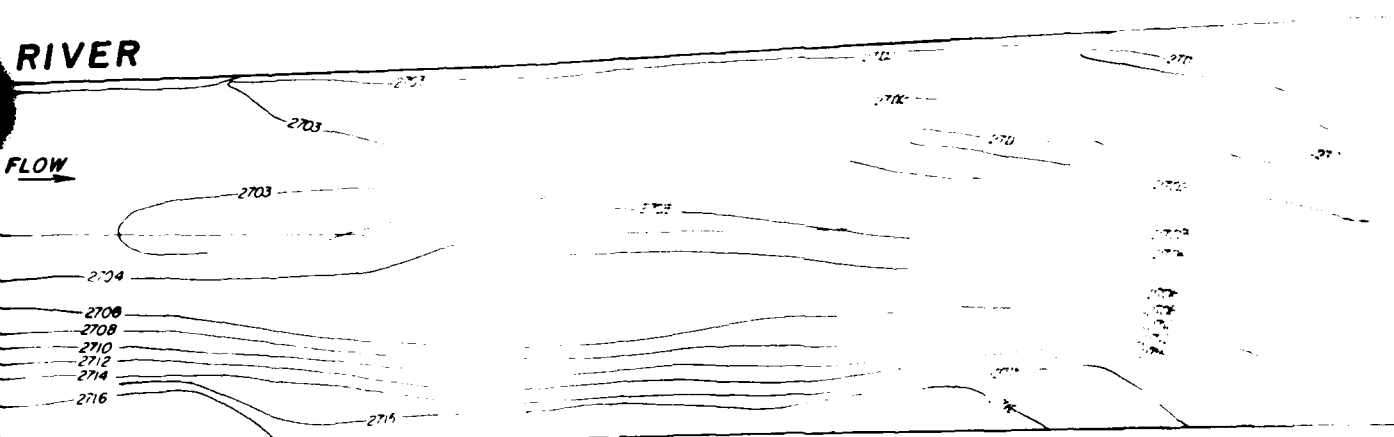
# EROSION AT CONFLUENCE

WINTER RAIN FLOOD

PLACER CREEK MAXIMUM DISCHARGE 3050 CFS  
SOUTH FORK COEUR D'ALENE RIVER DISCHARGE 7175 CFS

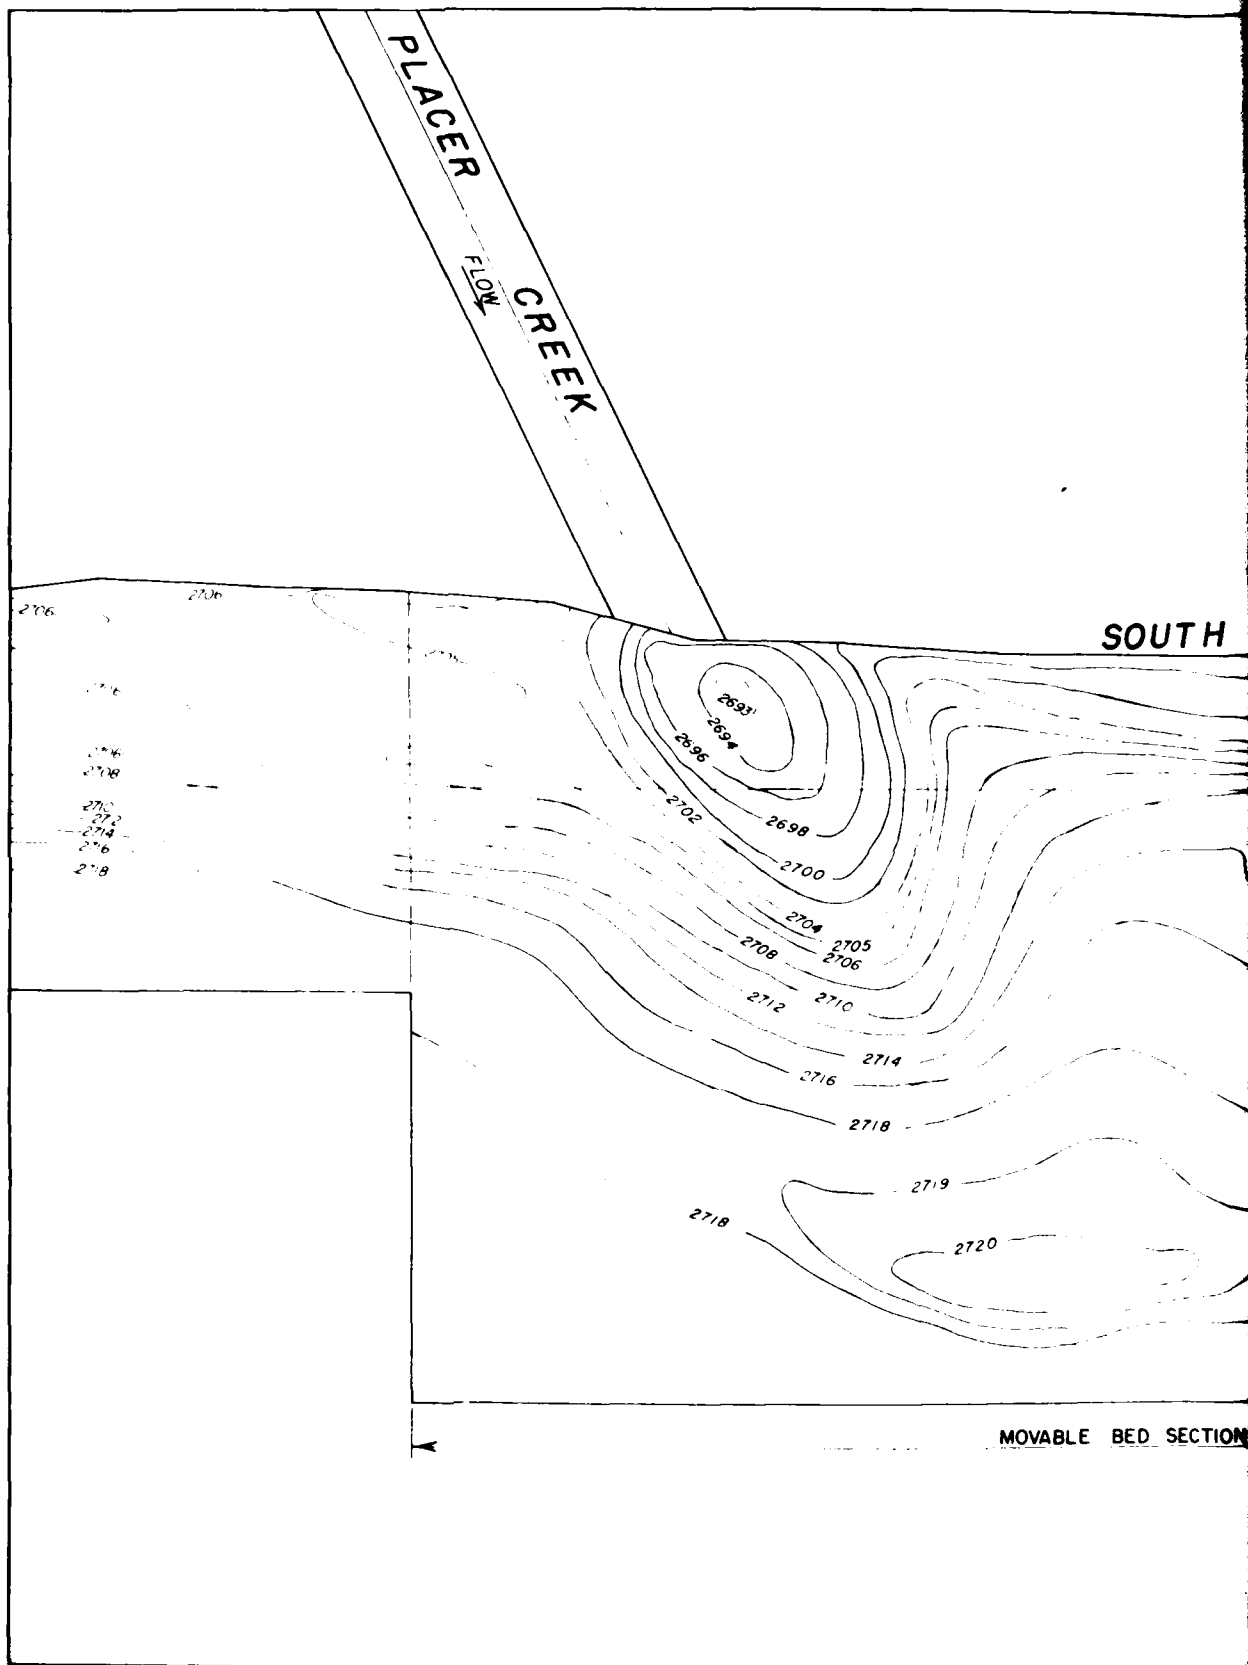
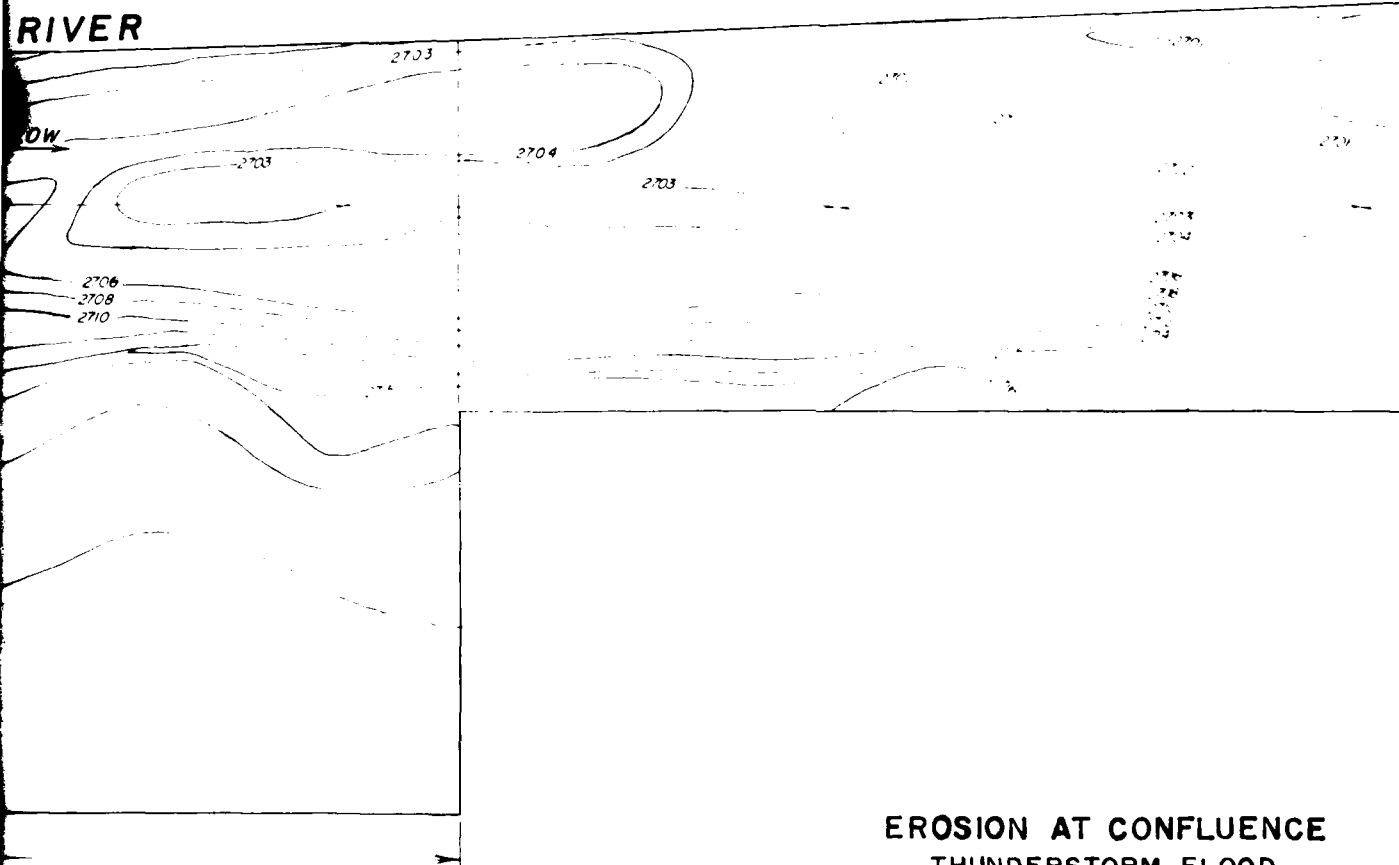
**EROSION AT CONFLUENCE**  
**THUNDERSTORM FLOOD**

PLACER CREEK MAXIMUM DISCHARGE 4600 CFS  
SOUTH FORK COEUR D'ALENE RIVER DISCHARGE 400 CFS
